Canterwood Division 12 STEP HOA
Community Walking Tour Meeting Minutes
October 18, 2018

Board of Directors Community Walk-Through

The Board met in the neighborhood to look at results of the Aadvanced Septic Services' infrastructure locating project and their 8 noted items. The results of their evaluation and Board additions/actions follow. Two additional items were added to their list by the Board as a result of the walk-through.

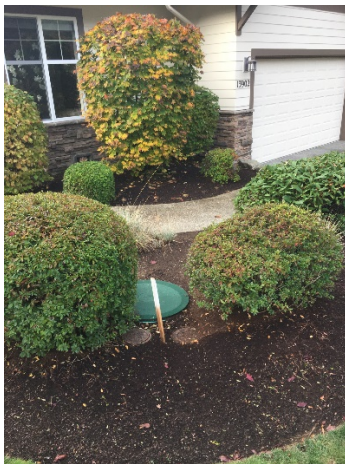
- 1) A 24" Riser with Air Vac Release Assembly and adjacent pony casting* for shut-off valve was found at **13902 49th Ave Ct NW**—not on the as-built drawings. Also found a second system pony casting for shut-off valve riser adjacent to Air Vac valve riser/shut-off—Outcome: The Board removed the marking stake and will note additions on as-builts.

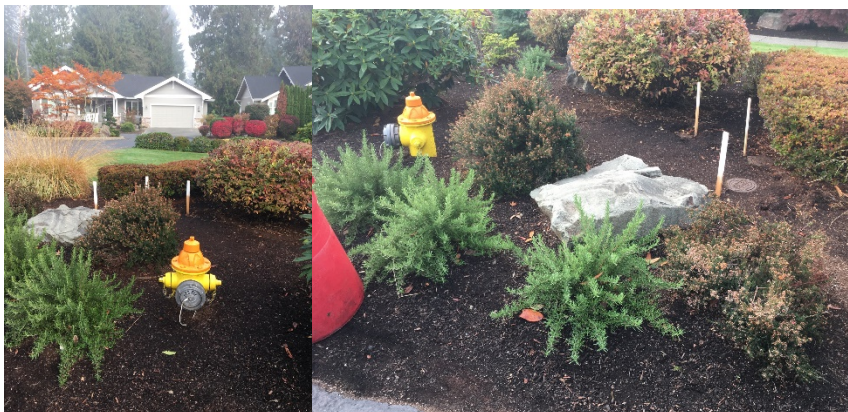
- 2) Three pony castings for shut-off valves in the flower garden at **13808 49th Ave Ct NW**--two at surface and another buried a few inches by mulch. --Outcome: Removed stakes and will notify property owner of infrastructure.

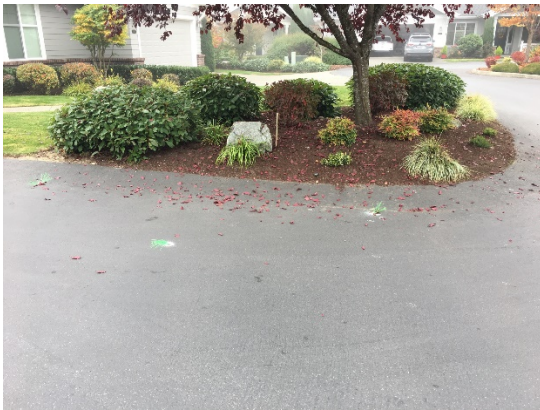
- 3) Three locations in the street marked with green whiskers and white paint and one additional location in adjacent garden under a large landscaping rock. 3 pony castings are suspected to be covered by asphalt and the 4th is suspected to be covered by large rock—next to stake in the picture below. Outcome: Further work needed to verify location through locate services. No excavation planned at this point. Will notify the homeowners at **13702 49th Ave Ct NW** about pending locate work and suspected buried valve that will potentially require future movement of the landscaping rock.

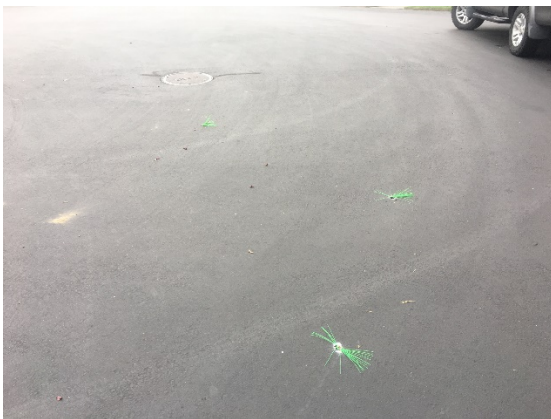
- 4) Three locations in street marked with green whiskers and white paint. Suspected “pony casting” locations for 3 valves that have likely been covered by asphalt. Outcome: Further work needed to verify location through locate services. No excavation planned at this point.

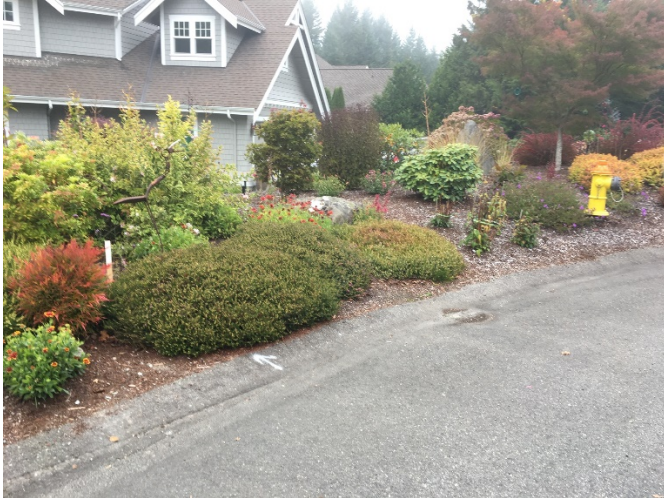
- 5) One pony casting found in garden below 16” of dirt (identified previously by the property owner). Two others noted on the as-builts were not found and are presumed buried. Outcome: More sophisticated locate services will be required in this area as there are several buried utility items in this location. Owners at **13706 47th Ave Ct NW** will be notified of pending locate work and the likely disruption needed to expose and raise the missing/buried pony castings.

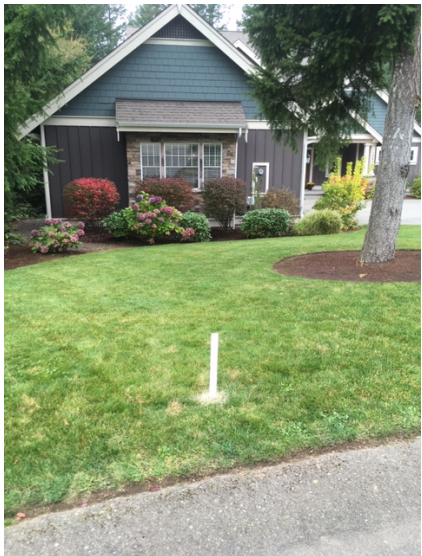
- 6) One suspected pony casting was marked in the lawn at **13806 47th Ave Ct NW**. Outcome: Owners will be notified of pending locate work and the likely disruption needed to expose and raise the missing/buried pony casting.

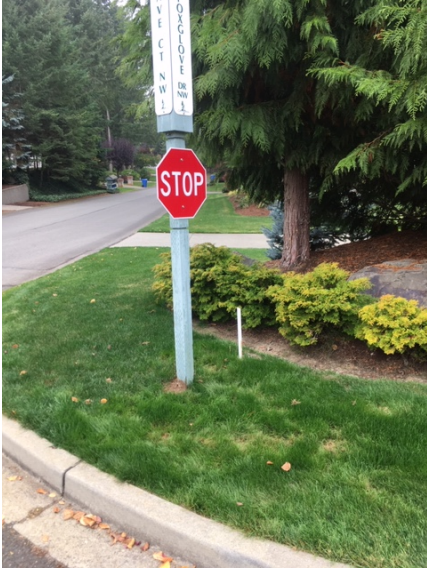
- 7) One suspected pony casting marked in the lawn at the corner of 47th Ave Ct NW and Foxglove was marked. Outcome: Owners at **4717 Foxglove** will be notified of pending locate work and the likely disruption needed to expose and raise the missing/buried pony casting.

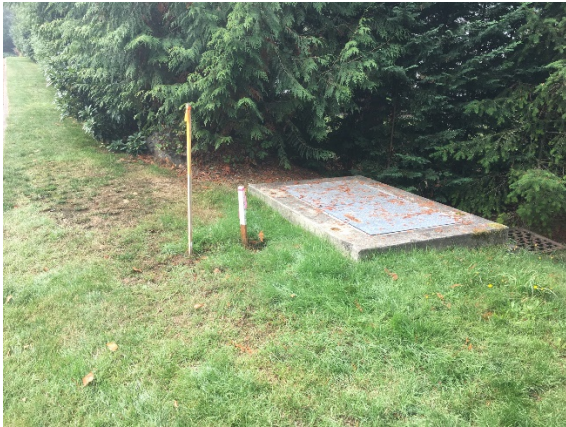
- 8) Pressure Sustaining Device Vault located on south side of 47th Ave Ct NW and Foxglove was opened and assessed by the Board. Outcome: Locate work will be performed around this vault to determine underground piping configuration.

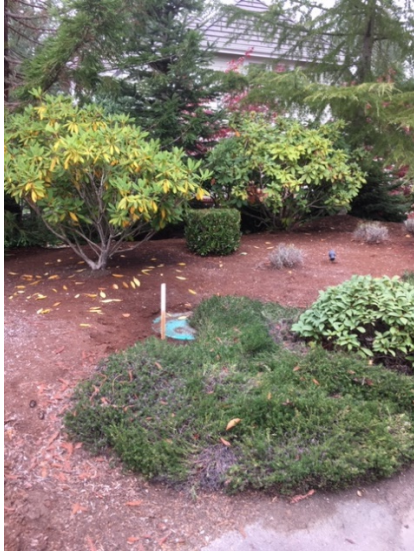
- 10) A partially buried Air Vac Release Assembly was located by the Board in a garden adjacent to the street at 13718 Whispering Pines. A cap is missing and the lid is not fastened down. The expected associated shut-off pony casting was not located and is likely under some plantings. Outcome: Owners will be notified of pending locate work and the likely disruption needed to expose /raise the missing/buried pony casting and the missing cap will be replaced and lid fastened.
