**Canterwood Division 12 STEP Association**  
**“Found” Infrastructure Locations and Maintenance Items**  
**November 4, 2022**

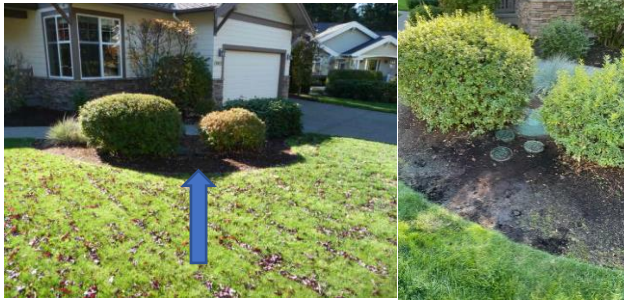
49 <sup>th</sup> Ave Ct NW					
Street Address	Lot #	Equipment	Quantity	Location Description/Comments	Location Picture
13902 49th Ave Ct NW	54	Pig port, <b>Inspect lid</b>	1	Located in landscaped area From apex of street corner— 16’ on a bearing of 202 degrees. All located in a 3’ diameter circle adjacent to the 24” riser lid

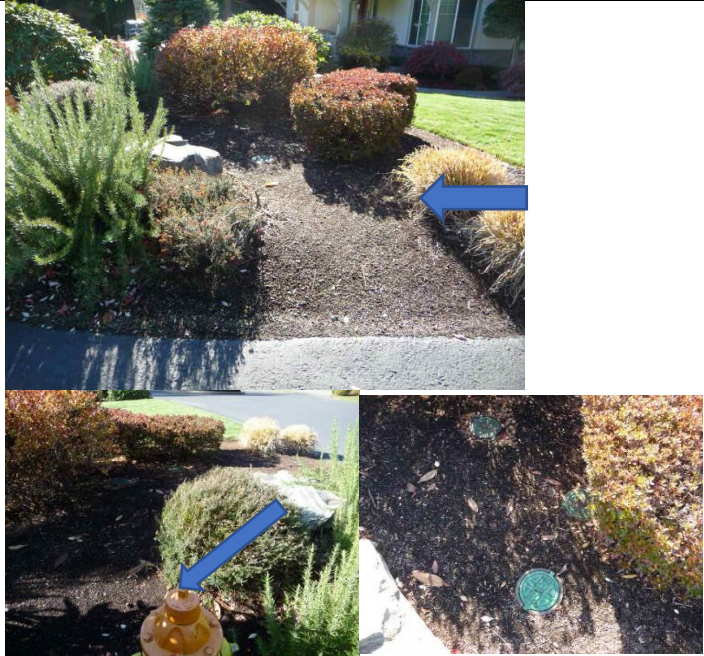
49 <sup>th</sup> Ave Ct NW					
Street Address	Lot #	Equipment	Quantity	Location Description/Comments	Location Picture
13808 49th Ave Ct NW	49	Line Shut-off Valves Exercise valves	3	Located in landscaped area; from fire hydrant-88" on a bearing of 275 degrees, from the asphalt on northside-98" on a bearing of 180 degrees S

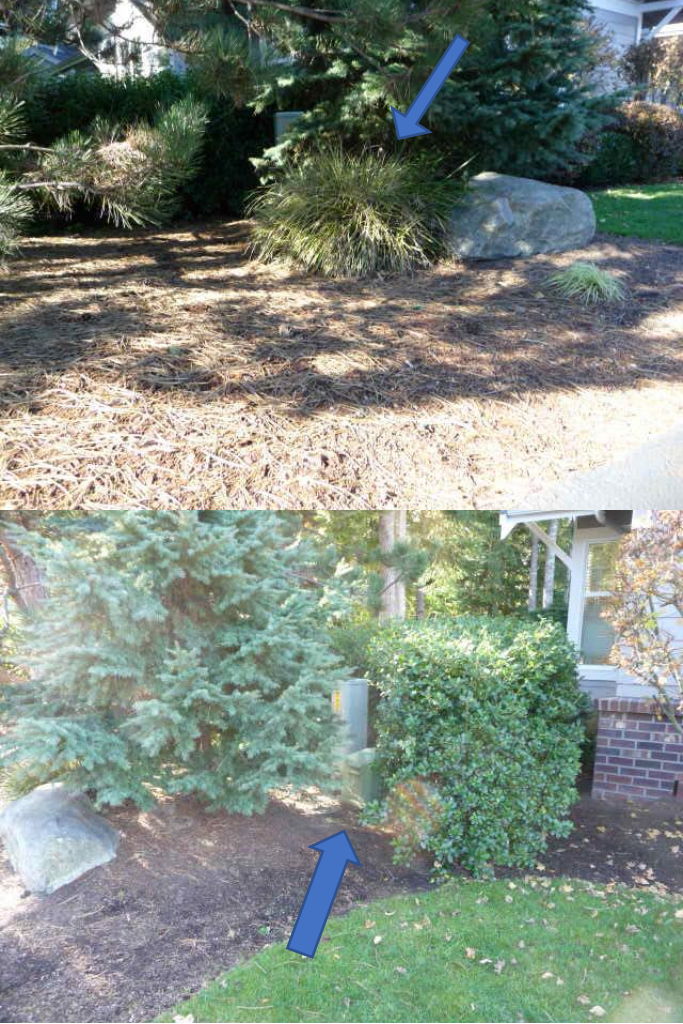
49 <sup>th</sup> Ave Ct NW					
Street Address	Lot #	Equipment	Quantity	Location Description/Comments	Location Picture
13702 49th Ave Ct NW	44	Line Shut-off Valves Exercise valves	4	Located in landscaped area nearest the street; 4 valves in a 4.5' diameter circle. Midpoint is 13.5' from asphalt on a bearing of 255 degrees from the non-arcing street edge. From the non-arcing street edge on the north side, valve center point is 10' from the asphalt on a bearing of 170 degrees S. <i>One valve is under Viburnum Shrub branches and not really visible in the picture—see arrow.</i>

49 <sup>th</sup> Ave Ct NW					
Street Address	Lot #	Equipment	Quantity	Location Description/Comments	Location Picture
13702 49th Ave Ct NW and common area Boundary	44	Line Shut-off Valves Exercise valves	3	Located at the lot and common area boundary within a cluster of utility structures—Phone and cable boxes under pine trees and behind grasses—see arrow. All are located within 1' from the Comcast/Cable box. One each on the North, East and South sides. All in a 4' diameter circle.

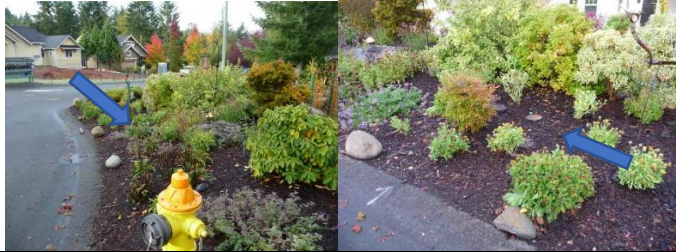
47 <sup>th</sup> Ave Ct NW and Stonebridge					
Street Address	Lot Number	Equipment	Quantity	Location Description/Comments	Location Picture
13706 47th Ave Ct NW	34	Line Shut-off Valves <b>Exercise</b>	3	3 valves in a 3.5' radius cluster, 21 feet SW from fire hydrant and 4 feet west from pavement edge

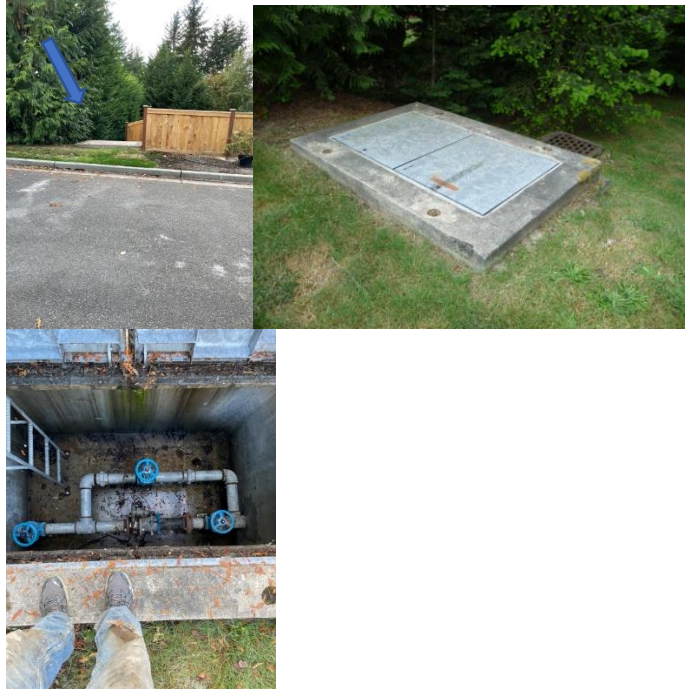
4720 Stonebridge Dr NW, vault actually located on 47 <sup>th</sup> Ave Ct NW	36	Vault <b>Exercise valves</b>	1	Contains 3 mainline valves, Pressure sustaining equipment; SW corner of lot; <b>Note: bypass valve was sticky (10/23/19), not as much of an issue in 2022.</b>

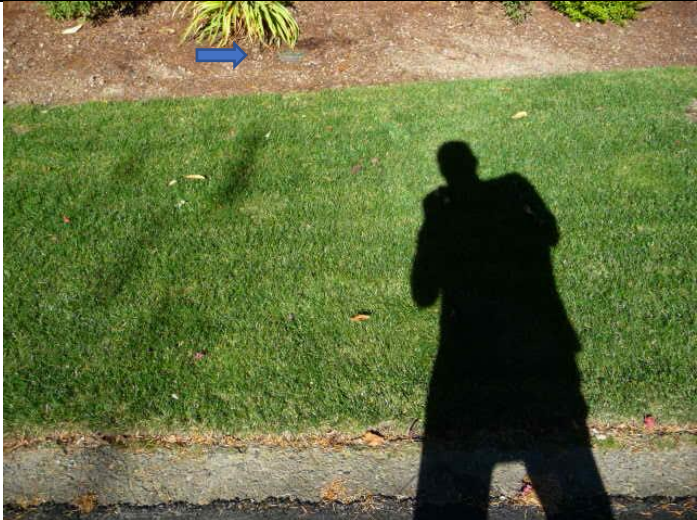
Foxglove					
Street Address	Lot Number	Equipment	Quantity	Location Description/Comments	Location Picture
4805 N Foxglove Dr NW	1	Line Shut-off Valve <b>Exercise</b>	1	Located in a landscaped area 105" perpendicular from asphalt and 41'3" from concrete driveway edge to the East and 42'8" from concrete driveway to the West.

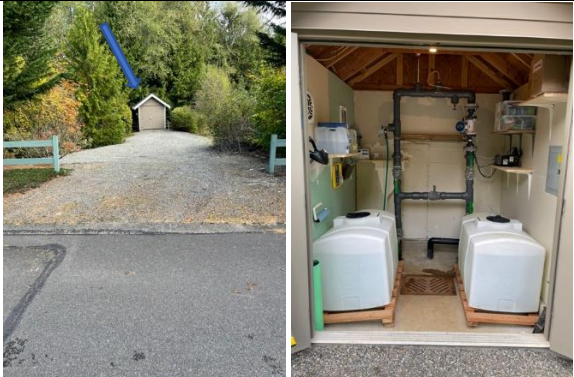
Near--south of 4805 N Foxglove Dr NW	Common Space	Treatment House <b>Exercise Valves</b>	1, 5	Access Road on North side of Foxglove adjacent to 4805 N Foxglove Dr NW. Contains 5 bypass valves, 2 tanks with valves, peristaltic pump, vacuum release valve, and flowmeter

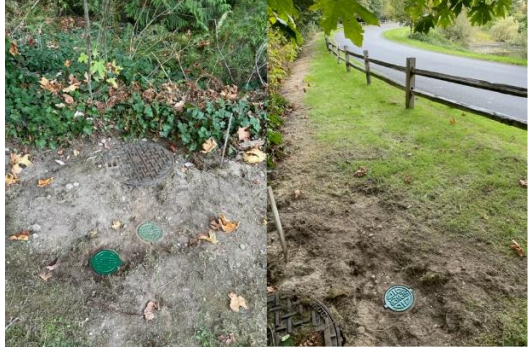
Foxglove					
Street Address	Lot Number	Equipment	Quantity	Location Description/Comments	Location Picture
Foxglove across from pond--no address	Street Shoulder	Low Point Drain and shutoff valve and mainline shutoff valve Exercise Mainline valve only	1,1,1	Located on the west side of Foxglove across from the large pond. 24" manhole with 2 adjacent valve risers located 12' from pavement edge and inside of rail fence. <b>Note: Vault fills with water. It appears the rubber seal/gasket was not properly installed as it was in the bottom of the vault. It is now stored in the pumphouse.</b>

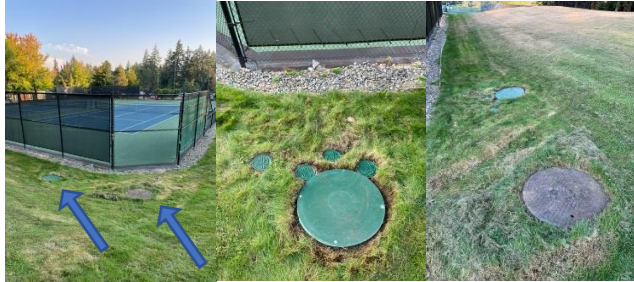
Old Stump Drive					
Street Address	Lot Number	Equipment	Quantity	Location Description/Comments	Location Picture
Across from 5634 Old Stump Drive	XX	1 Pig Port w 3 valves, 1 mainline shut-off valve and 1 Air vacuum release inspect lid and exercise valves	1,3,1,1	Adjacent to the NW corner of the western most Club Corp tennis court. Courts are across from 5634 Old Stump Drive. <b>The Air vacuum release equipment is severely corroded. The vault lid will not seal as the mating service has slipped.</b>

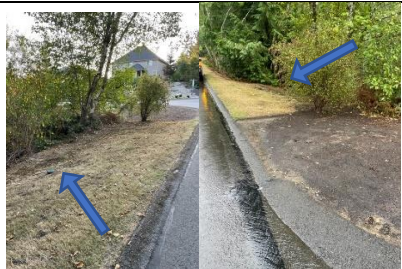
Across from 5517 Old Stump Drive	XX	Mainline Shut-off valve, Exercise valve	1	Located on the SE side of Old Stump, 10' from pavement edge and ~35' east of the pavement edge at the side of the intersection of Old Stump and 56 <sup>th</sup> Ave NW.

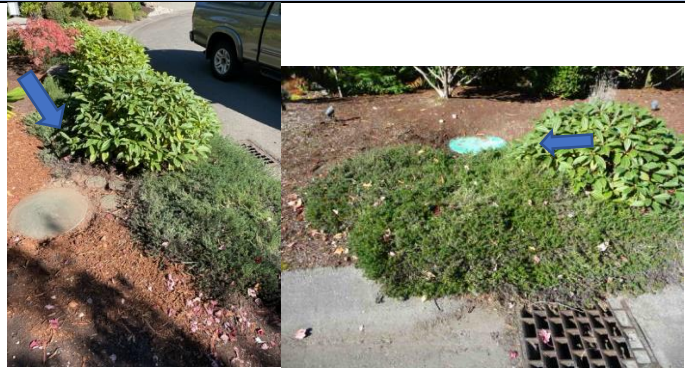
Whispering Pines (AKA 45 <sup>th</sup> Ave Ct NW)					
Street Address	Lot Number	Equipment	Quantity	Location Description/Comments	Location Picture
13718 Whisp. Pns Dr NW	12	Pig port and 3 associated valves, Exercise 3 valves; inspect lid	1, 3	Located in a landscaped area 8' from the street storm drain at a bearing of 300 degrees. Three shut-off valves located 1' from 24" septic tank/pig port lid

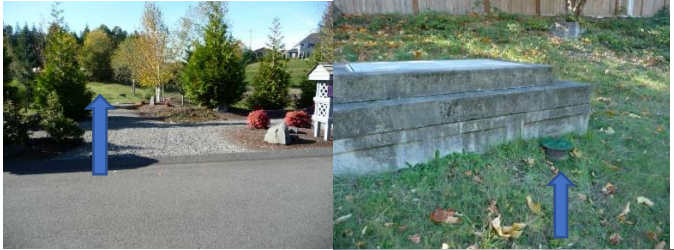
55 <sup>th</sup> Ave Ct NW					
Street Address	Lot Number	Equipment	Quantity	Location Description/Comments	Location Picture
Across From- 12125 55 <sup>th</sup> Ave Ct NW	None	Vault Exercise	1	Contains 3 valves and terminal flow meter

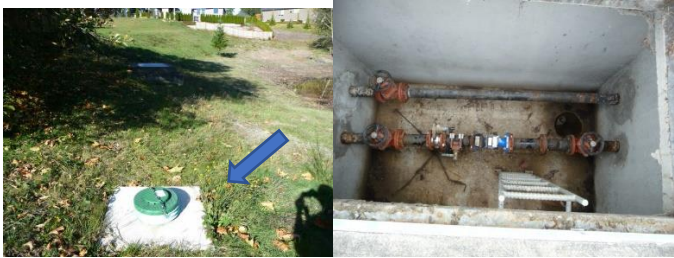
None	Line Shut-off Valve Exercise	1	Valve is adjacent to vault— NE Corner, valve appears to be vault drain— <b>requires 8' wrench</b>	
	None	Aerator Remove Lock—Oil lock, remove outer aerator lid and inner lid and make sure "free fall" ports are free of debris, inspect lid	1	Take access "road" between stormwater retention ponds. Equipment is near perimeter fence. Aerator is 23 feet S from vault
