**Canterwood Division 12 STEP Association**  
**"Found" Infrastructure Locations and Maintenance Items**  
**August 29, 2026**

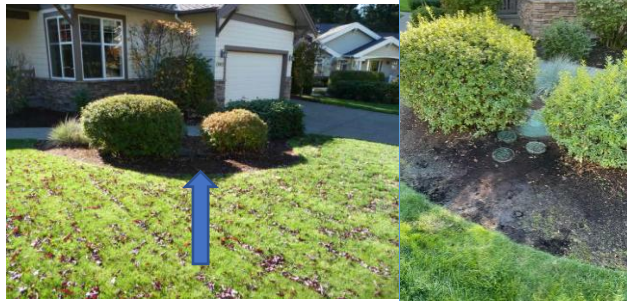
| 49 <sup>th</sup> Ave Ct NW | | | | | |
|---|---|---|---|---|---|
| 13902 49th Ave Ct NW | 54 | Pig port,<br>Inspect lid | 1 | Located in landscaped area<br>From apex of street corner—<br>16' on a bearing of 202<br>degrees. All located in a 3'<br>diameter circle adjacent to<br>the 24" riser lid | |

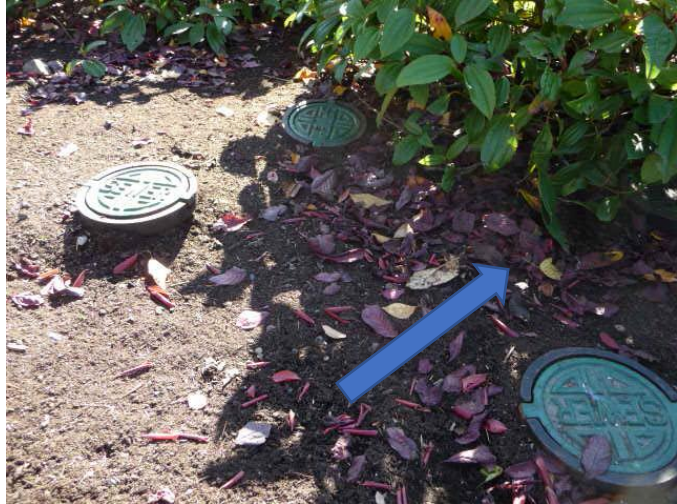
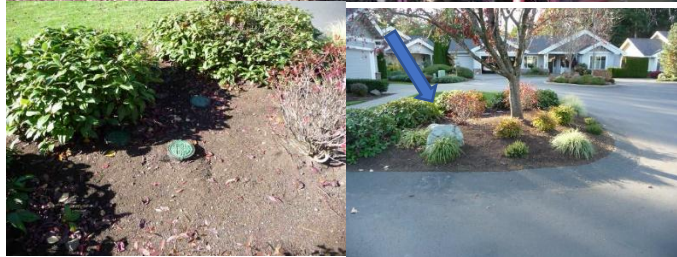
| 49 <sup>th</sup> Ave Ct NW | | | | | |
|---|---|---|---|---|---|
| 13702 49th Ave Ct NW | 44 | Line Shut-off Valves<br>Exercise valves | 4 | Located in landscaped area nearest the street; 4 valves in a 4.5' diameter circle. Midpoint is 13.5' from asphalt on a bearing of 255 degrees from the non-arc street edge. From the non-arc street edge on the north side, valve center point is 10' from the asphalt on a bearing of 170 degrees S. <i>One valve is under Viburnum Shrub branches and not really visible in the picture—see arrow.</i> | |

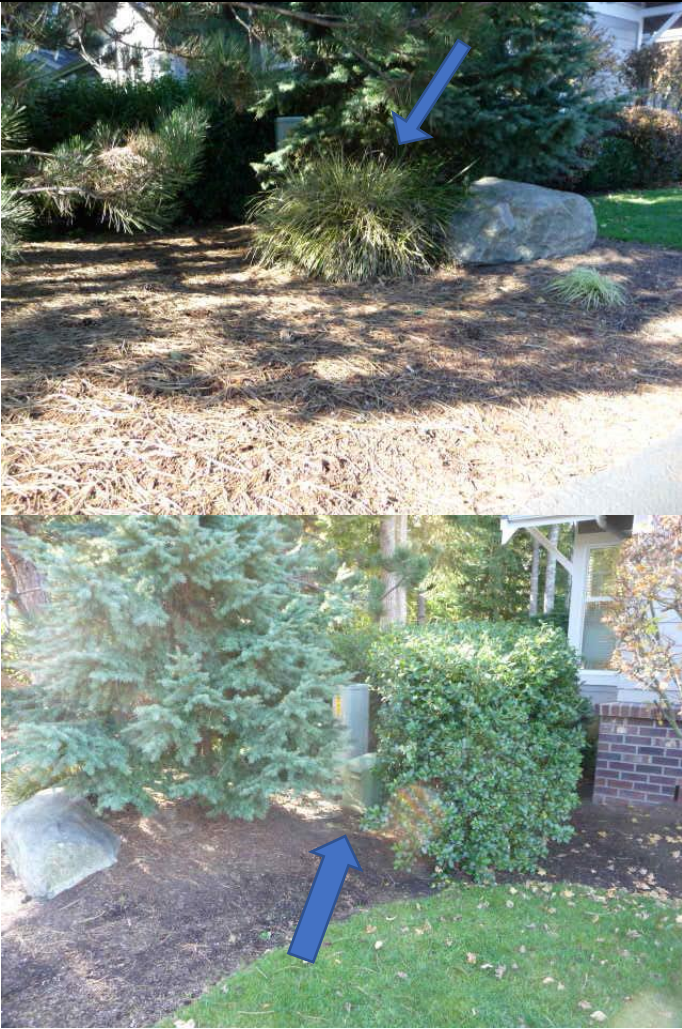
| 49 <sup>th</sup> Ave Ct NW | | | | | |
|---|---|---|---|---|---|
| 13702 49th Ave Ct NW and common area Boundary | 44 | Line Shut-off Valves<br>Exercise valves | 3 | Located at the lot and common area boundary within a cluster of utility structures—Phone and cable boxes under pine trees and behind grasses—see arrow. All are located within 1' from the Comcast/Cable box. One each on the North, East and South sides. All in a 4' diameter circle. | |

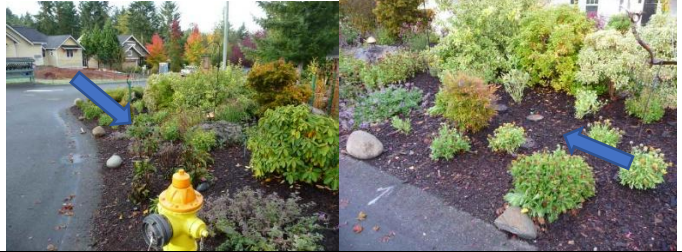
| 47 <sup>th</sup> Ave Ct NW and Stonebridge | | | | | |
|---|---|---|---|---|---|
| 13706 47th Ave Ct NW | 34 | Line Shut-off Valves<br>Exercise | 3 | 3 valves in a 3.5' radius cluster, 21 feet SW from fire hydrant and 4 feet west from pavement edge | |

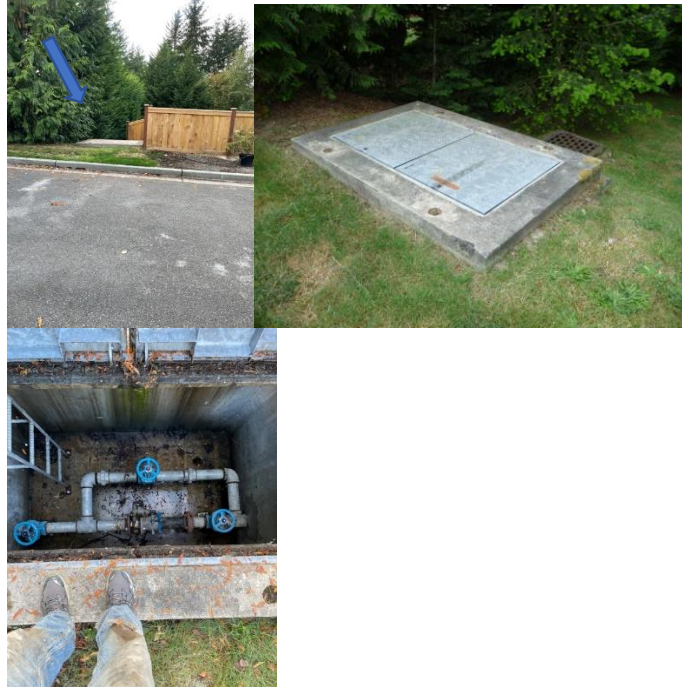
| 47 <sup>th</sup> Ave Ct NW and Stonebridge | | | | | |
|---|---|---|---|---|---|
| 4720 Stonebridge Dr NW, vault located on 47 <sup>th</sup> Ave Ct NW | 36 | Vault<br>Exercise valves | 1 | Contains 3 mainline valves, Pressure sustaining equipment; SW corner of lot;<br><b>Note: bypass valve was sticky (10/23/19), not as much of an issue in 2022.</b> | |

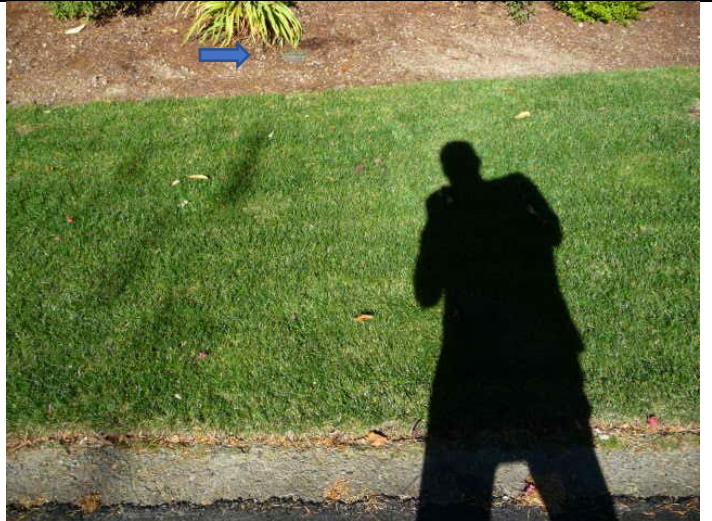
| Street Address | Lot Number | Equipment | Quantity | Location Description/Comments | Location Pictures |
|---|---|---|---|---|---|
| 4805 N Foxglove Dr NW | 1 | Line Shut-off Valve<br>Exercise | 1 | Located in a landscaped area 105" perpendicular from asphalt and 41'3" from concrete driveway edge to the East and 42'8" from concrete driveway to the West. | |

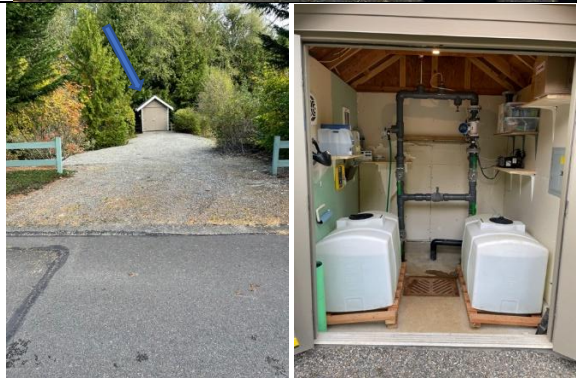
| Street Address | Lot Number | Equipment | Quantity | Location Description/Comments | Location Pictures |
|---|---|---|---|---|---|
| Near-- south of 4805 N Foxglove Dr NW | Common Space | Treatment House<br>Exercise<br>Bypass<br>Valves | 1, 5 | Access Road on North side of Foxglove adjacent to 4805 N Foxglove Dr NW. Contains 5 bypass valves, 2 tanks, peristaltic pump, vacuum release valve, and flowmeter | |

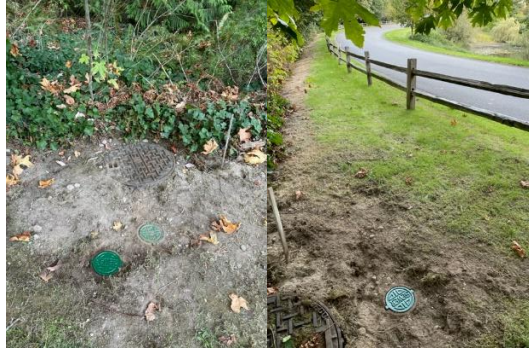
| Street Address | Lot Number | Equipment | Quantity | Location Description/Comments | Location Pictures |
|---|---|---|---|---|---|
| Foxglove across from pond--no address | Street Shoulder | Low Point Drain and shutoff valve and mainline shutoff valve<br>Exercise Mainline valve only | 1,1,1 | Located on the west side of Foxglove across from the large pond. 24" manhole with 2 adjacent valve risers located 12' from pavement edge and inside of rail fence.<br><b>Note: Vault fills with water. It appears the rubber seal/gasket was not properly installed as it was in the bottom of the vault. It is now stored in the pumphouse.</b> | |

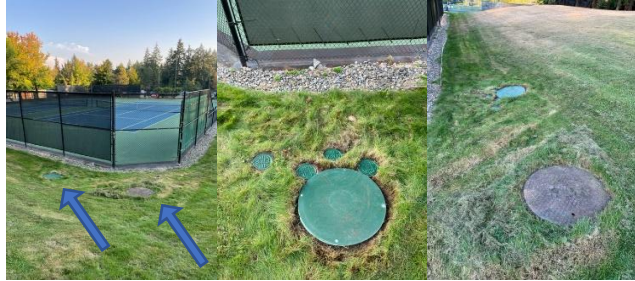
| Street Address | Lot Number | Equipment | Quantity | Location Description/Comments | Location Pictures |
|---|---|---|---|---|---|
| Across from 5634 Old Stump Drive | Club Corp Property | 1 Pig Port w 3 valves, 1 mainline shut-off valve and 1 Air vacuum release<br>inspect lid and exercise valves | 1,3,1,1 | Adjacent to the NW corner of the western most Club Corp tennis court. Courts are across from 5634 Old Stump Drive. <b>The Air vacuum release equipment is severely corroded. The vault lid will not seal. Air Vac is offline and no repairs are planned.</b> | |

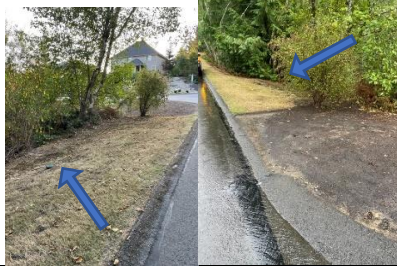
| Across from 5517 Old Stump Drive | XX | Mainline Shut-off valve,<br>Exercise valve | 1 | Located on the SE side of Old Stump, 10' from pavement edge and ~35' east of the pavement edge at the side of the intersection of Old Stump and 56 <sup>th</sup> Ave NW. | |

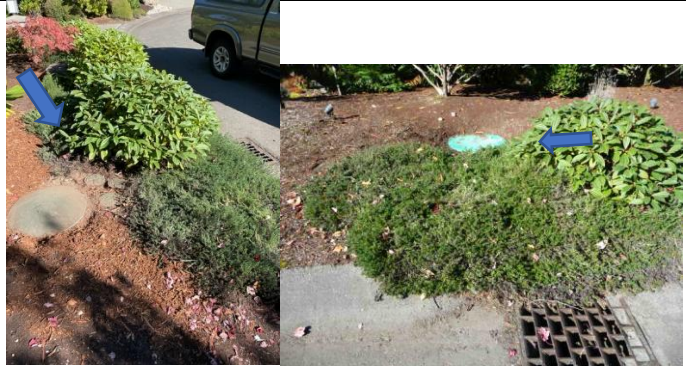
| Across from 5517 Old Stump Drive | XX | Mainline Shut-off valve,<br>Exercise valve | 1 | Located on the SE side of Old Stump, 10' from pavement edge and ~35' east of the pavement edge at the side of the intersection of Old Stump and 56 <sup>th</sup> Ave NW. | |
|---|---|---|---|---|---|
| 13718 Whisp. Pns Dr NW | 12 | Pig port and 3 associated valves,<br>Exercise 3 valves;<br>inspect lid | 1, 3 | Located in a landscaped area 8' from the street storm drain at a bearing of 300 degrees. Three shut-off valves located 1' from 24" septic tank/pig port lid | |

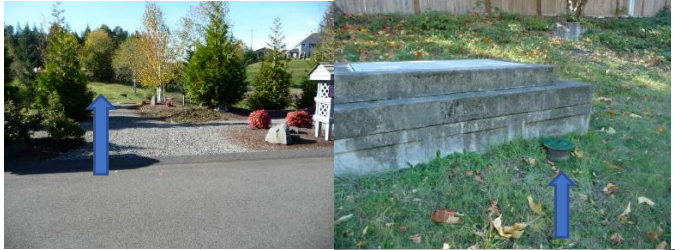
| 55 <sup>th</sup> Ave Ct NW | | | | | |
|---|---|---|---|---|---|
| Across From- 12125 55 <sup>th</sup> Ave Ct NW | None | Vault<br>Exercise | 1 | Take access “road” between stormwater retention ponds. Equipment is near perimeter fence. Contains 3 bypass valves and terminal flow meter. Change flow meter battery after 4.5 years. Install date was 12-2023. | |

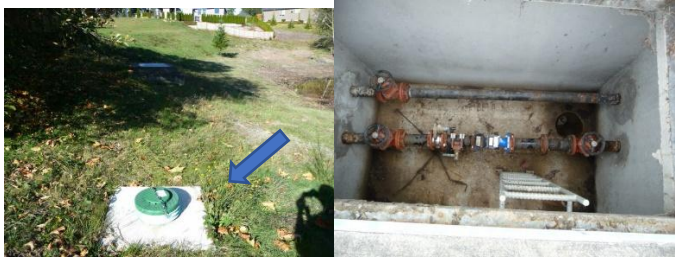
| 55 <sup>th</sup> Ave Ct NW | | | | | |
|---|---|---|---|---|---|
| | None | Line Shut-off Valve<br>Exercise | 1 | Valve is adjacent to vault—NE Corner, valve appears to be vault drain— <b>requires 8’ wrench. Stays closed.</b> | |
